Dato VK loves golf. Striding away the clubs sending the ball high up to the sky, he loves the serenity of the game. It made him feel closer towards nature. One bad golfing incident had caused him teeth. Not a nice sight for a reputed golfer, sitting among the ministers during conferences, director meetings, and luxurious high teas.

His secretary called in one morning, making a dental appointment for him. The story narrated by his secretary was not so detailed, so we decided to take a closer look at his dental condition.

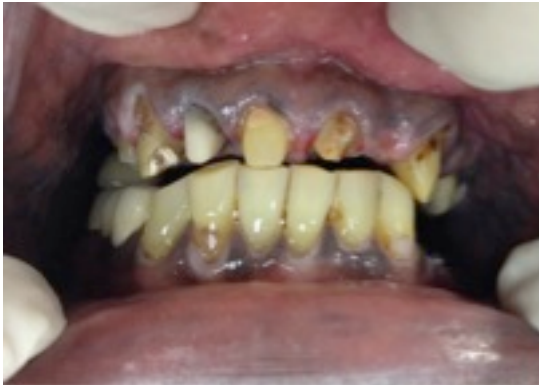
The damage was bad. The golf ball was cruel enough to destroy most of his upper teeth. The blow was severe, causing him a couple of laceration wounds, and fractured teeth. We decided to take his teeth to the next level.
